# Mobile Intel® Pentium® 4 Processor-M

Specification Update

*October 2006*

Document Number: 250721-036

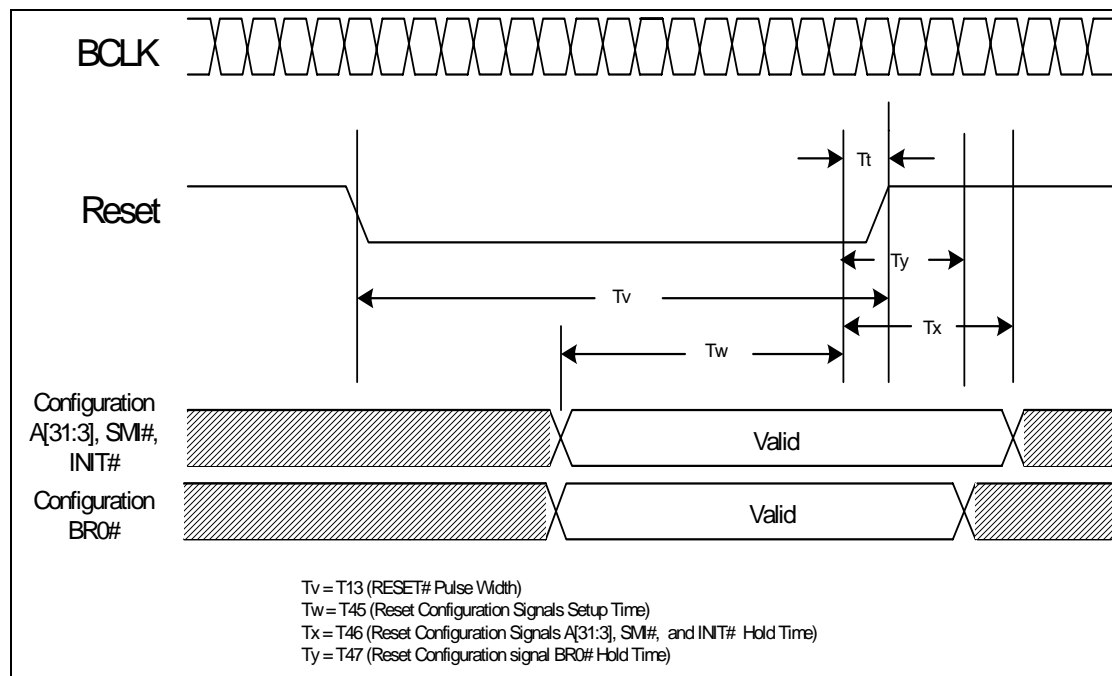
**Figure 13. System Bus Reset and Configuration Timings**

The BR0# maximum hold time has changed to 2 BCLKs. This change will be shown in the “System Bus AC Specifications (Reset Conditions)” table and “System Bus Reset and Configuration Timings” figure of the *Mobile Intel® Pentium® 4 Processor - M Datasheet*. This change will be incorporated in the next revision of the datasheet.

The following figure will be modified to reflect this change:
